Service Bulletin TV Products

Model: KP-41T35, KP-41T65, KP-46C36, KP-46C65,

Subject: Countermeasure for Video Amp IC failure and

CRT phosphor damage.

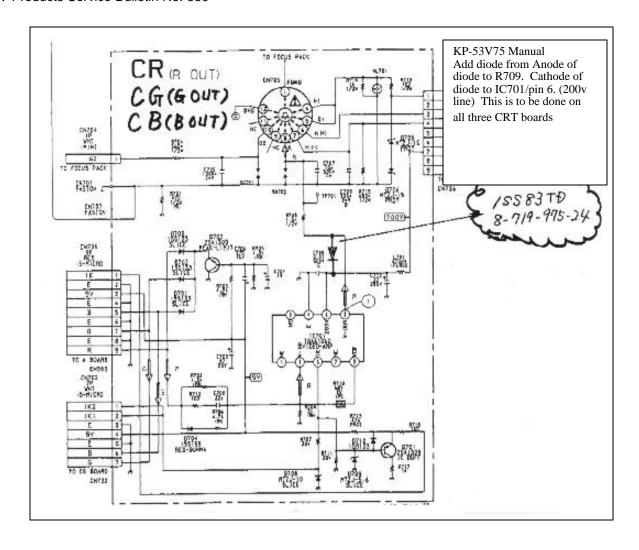
Fig 1

(1311) Video Amp failure with possible CRT damage, due to CRT arcing

- 1. Mount a diode on the "solder" side of all three CRT boards CR, CG, and CB boards. The diode should be mounted across IC701/pin6 and 8 to the three See fig 1.
- 2. Redress the HV leads and use a Tie lock to attach the FBT lead to the Anode lead for the Red CRT. See fig 2
- 3. Place RTV over the diode to secure it to the board.
